CHAPTER 17

SOIL AND LAND QUALITY

17 Soil and Land Quality

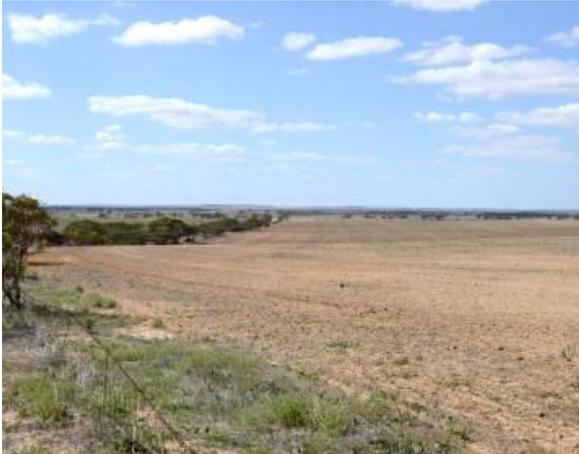
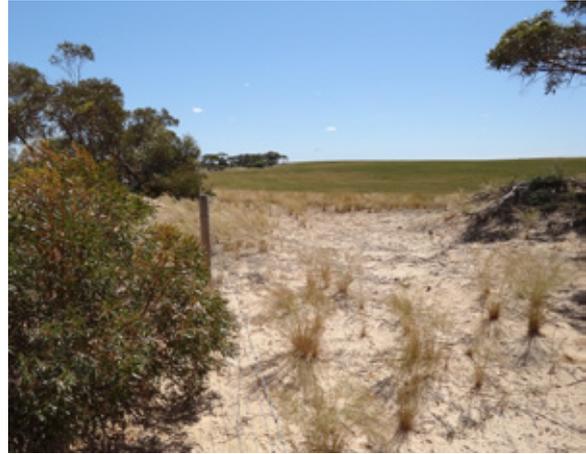
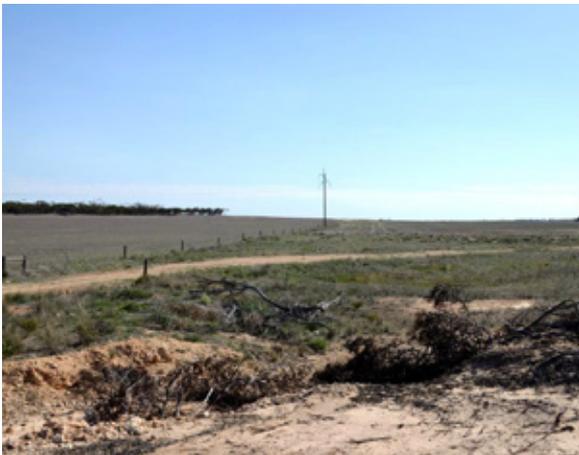
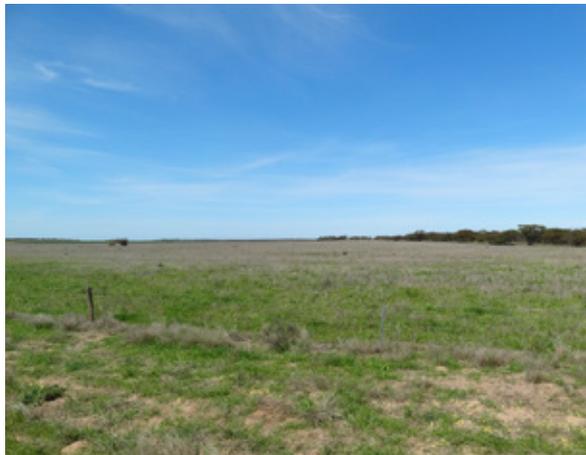
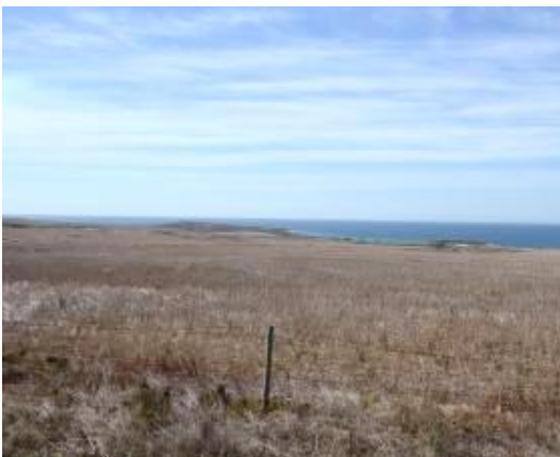
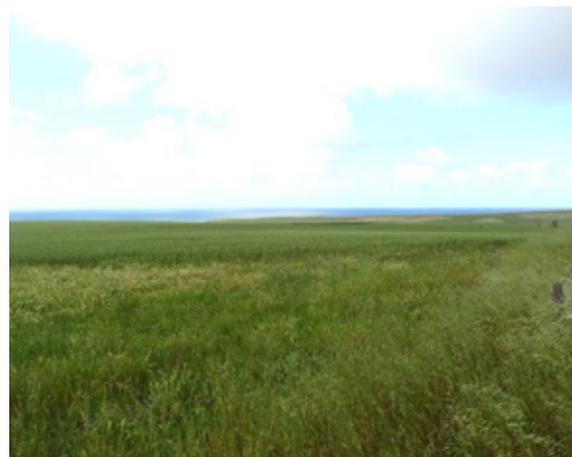
Plate 17-1 Landscapes Throughout the CEIP Infrastructure

The site of the proposed CEIP Infrastructure (Plate 17-1) is typically located within undulating sand plains, with inliers of hard basement rock protruding from the surface. The sand comprises older, eroded and partly consolidated carbonate sands of the Bridgewater Formation in the western half of the project area, with younger overlying quartz sands in the north and east (e.g. Moornaba Sand). Calcrete in sheet, rubble, nodular and powder forms is present to varying degrees in both of these geological units. In general, the older the host rock the more indurated the calcrete (Jacobs 2014a; 2014b; 2014c).
